Joint Network Secretariat
Normal Procedure Task Force
Broken wheels

Brussels, 28. November 2019

Final output

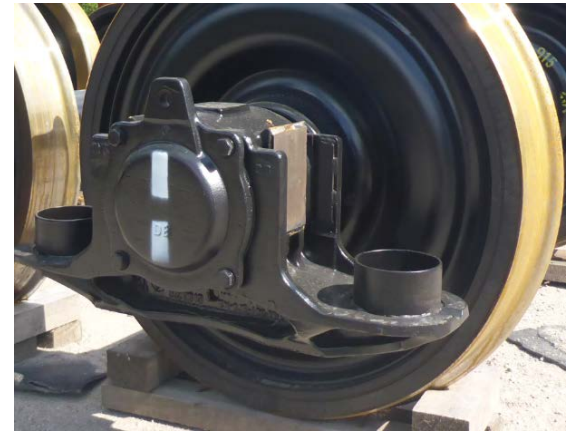
On non-thermostable wheels (without white marks on the axle box cover) the following measures has to be performed on thermally overloaded wheels:

- Residual stress measurement*
- Measurement back to back distance between the wheels
- Reprofilng
- NDT of the tread*

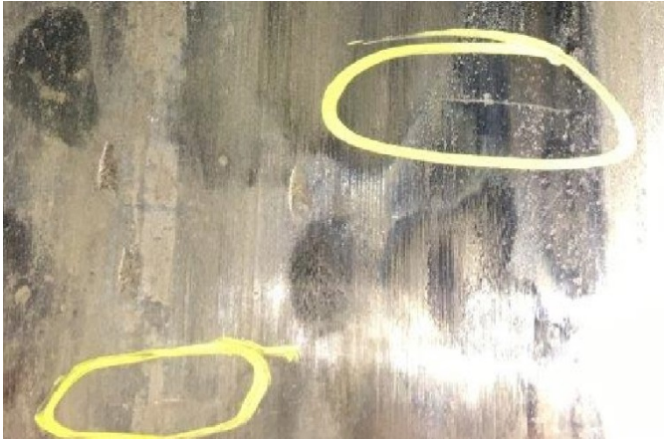
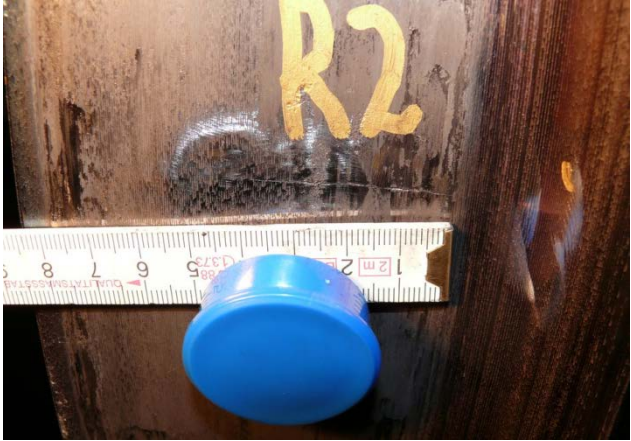
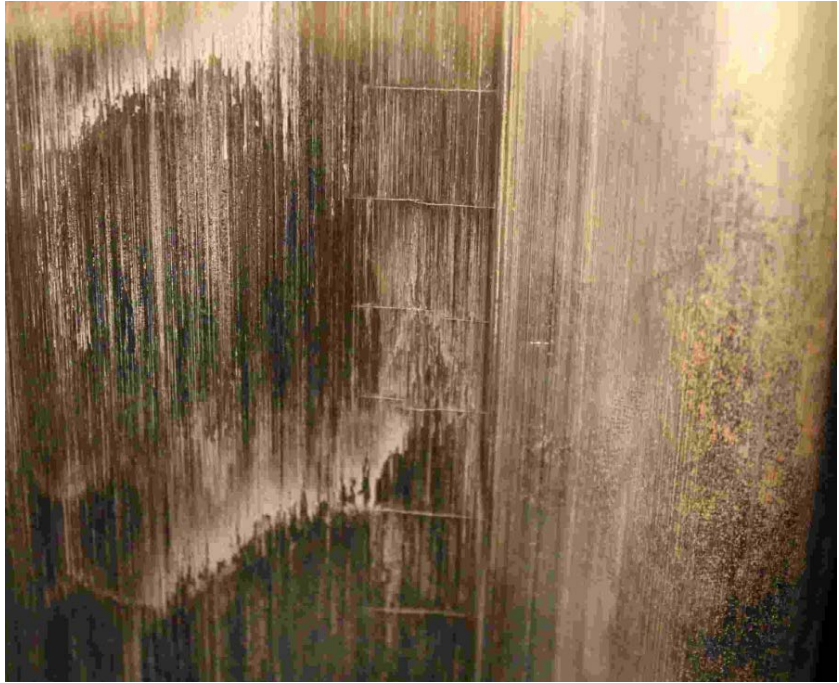
Example for single cracks on the wheel tread by visual inspection

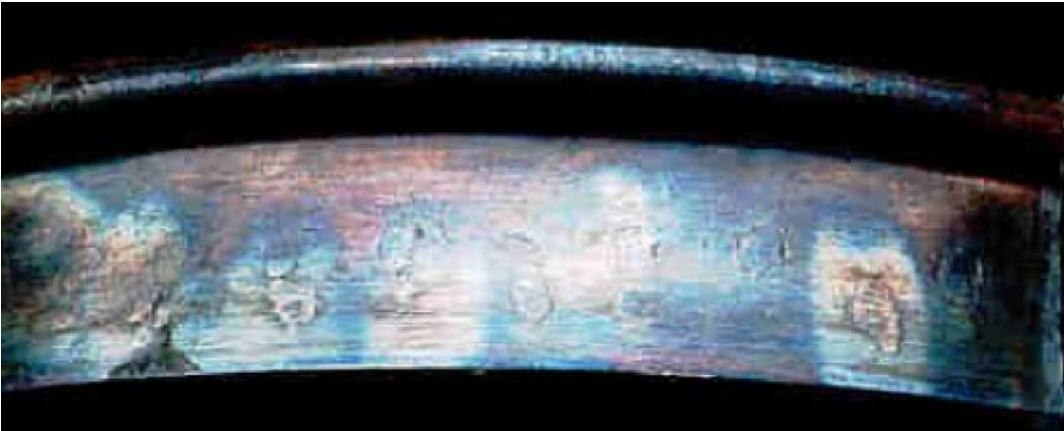
colouring on the tread

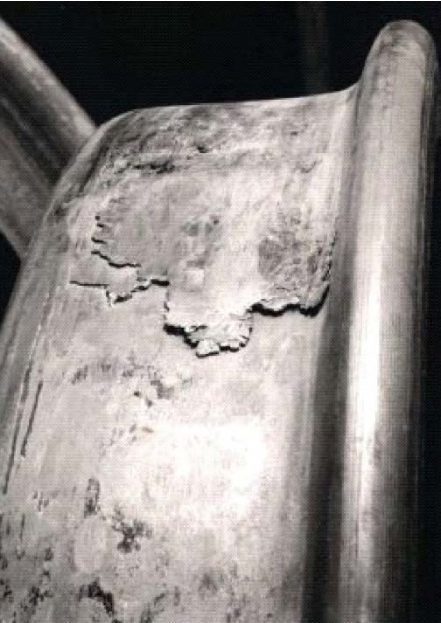
Metal build up on the tread

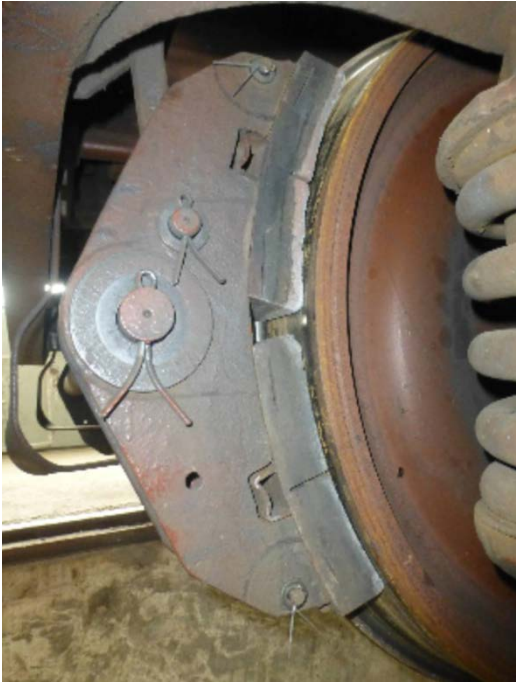
Melted brake block
